# THE BUFFALO CREEK FLOOD AND DISASTER

OFFICIAL REPORT FROM THE GOVERNOR'S  
AD HOC COMMISSION OF INQUIRY

THE BUFFALO CREEK  
FLOOD AND DISASTER

Official Report from the Governor's  
Ad Hoc Commission of Inquiry

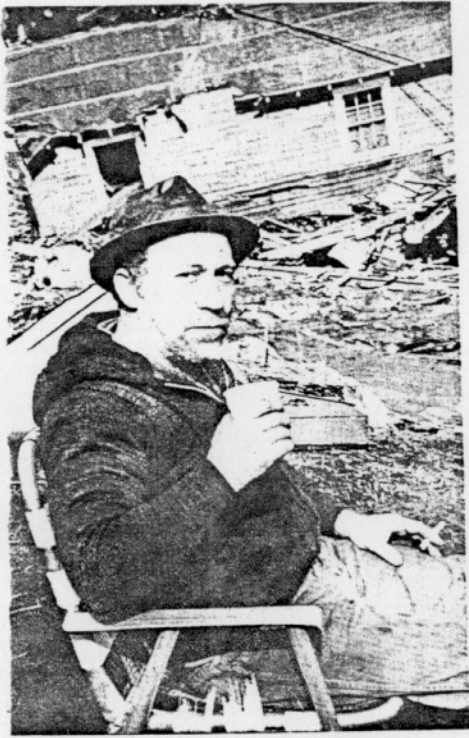
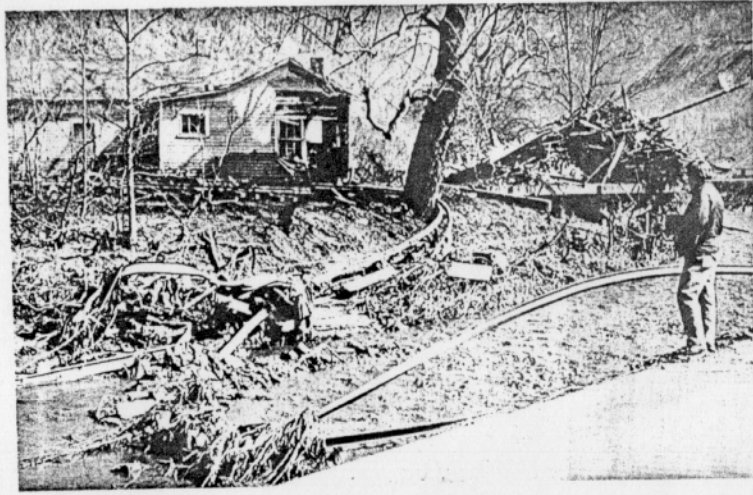
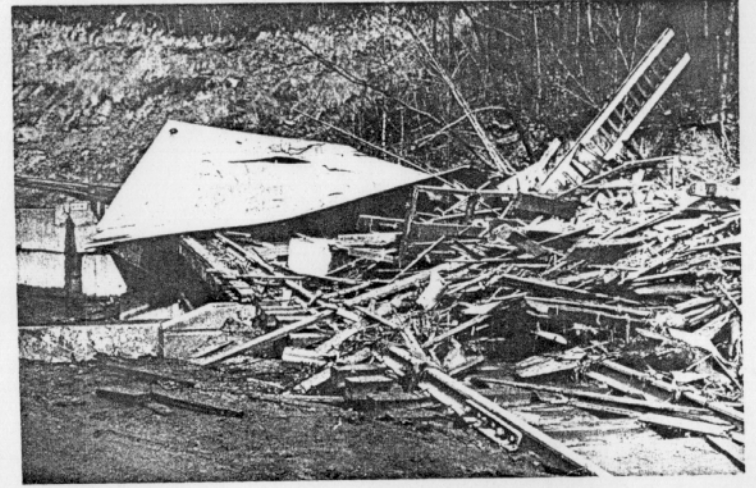
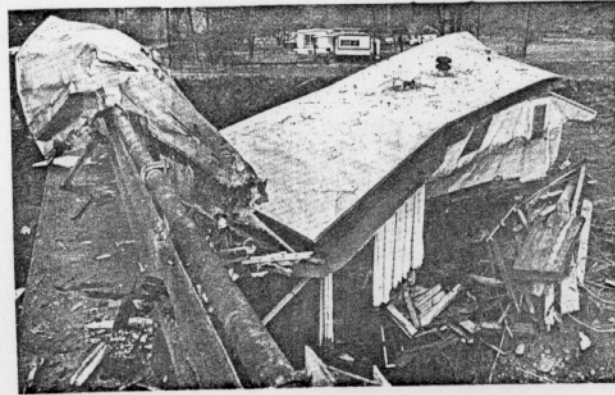
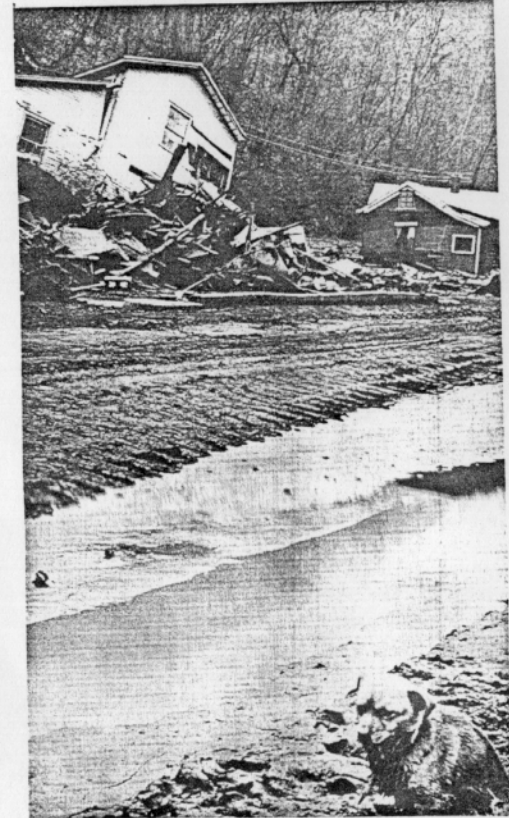
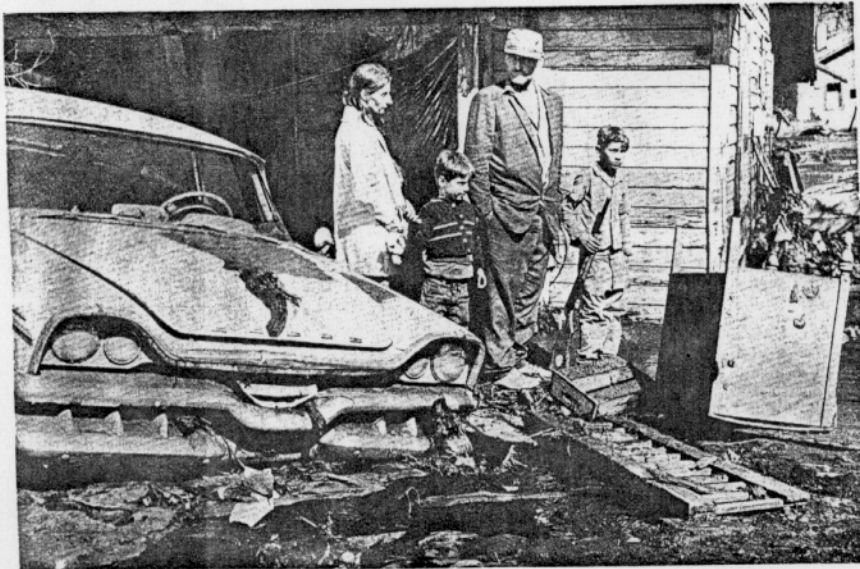
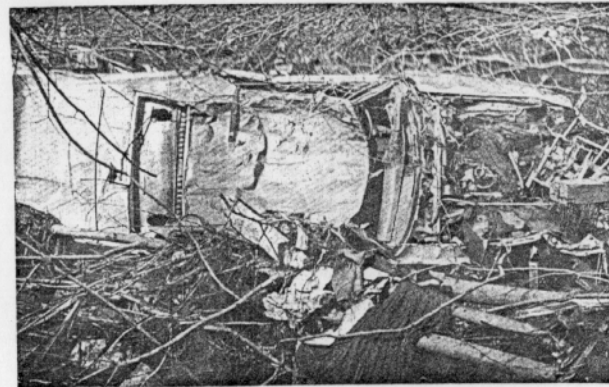
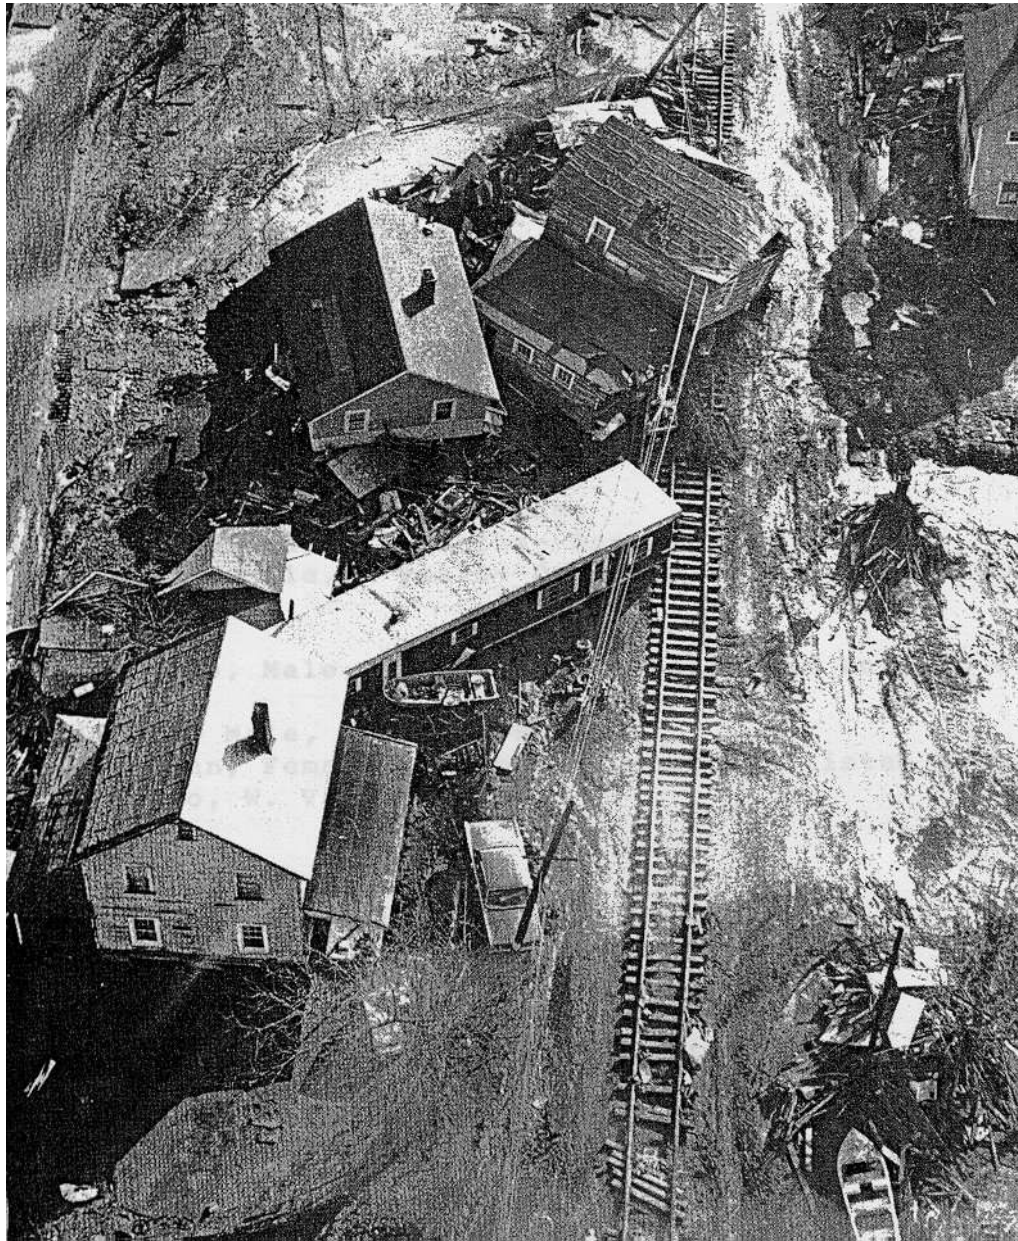
Figure 1-3 Typical Photographs of Flood Damage

In addition, 30 business establishments, 1000 automobiles and trucks, 10 bridges, and power, water and telephone lines were all destroyed, and the county road and the rail lines servicing the valley's coal mines were severely damaged. The photographs in Figure 1-3 are typical of the tremendous damage done by the flood.

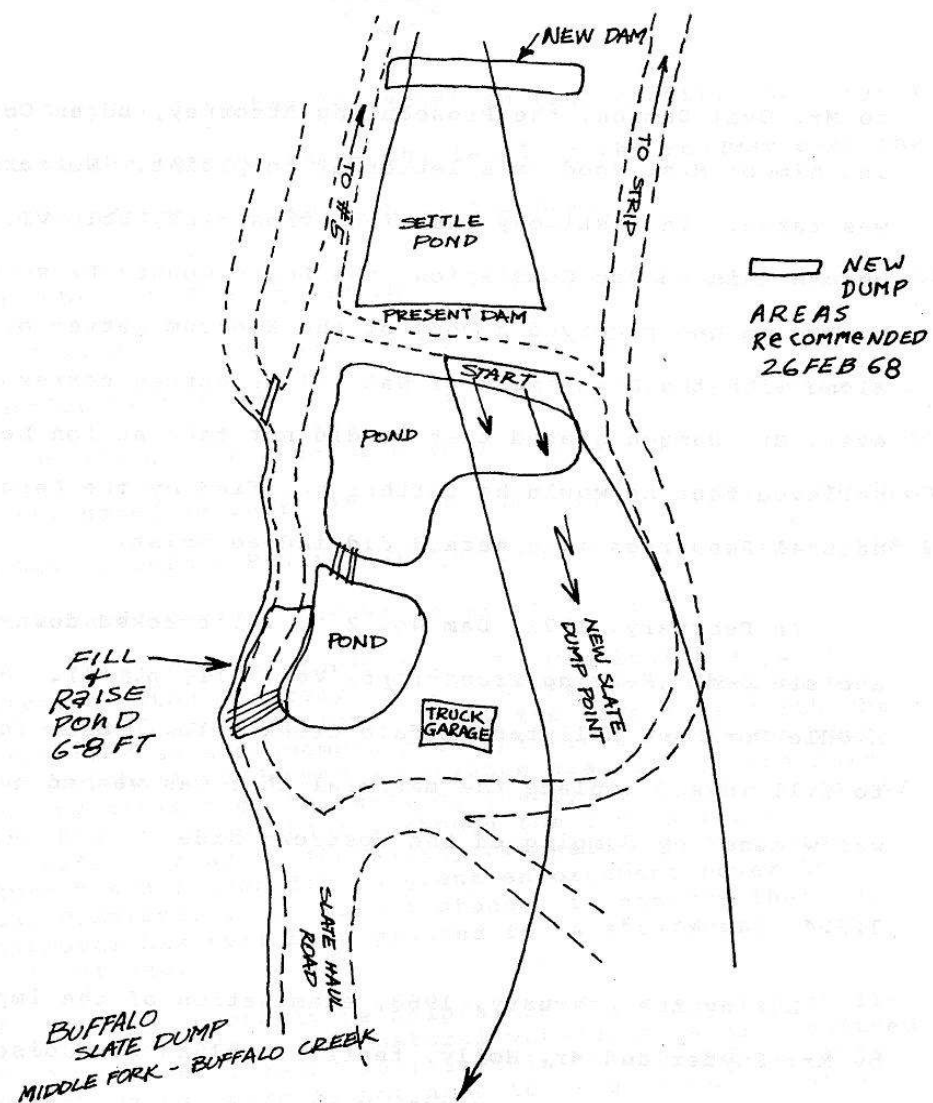
Figure 2-2 Saovich's sketch of dumping plan, dated February 26, 1968

During the February, 1968, examination of the impoundment areas by Mr. Snyder and Mr. Holly, tentative plans were discussed for a new impoundment 600 feet up middle Fork. Mr. D. S. Dasovich, Vice-President, Buffalo Mining Company, made a drawing showing the procedure for constructing the new impoundment (Figure 2-2). As an alternative, he suggested that the most effective method to insure against a washout would be to widen Dam No. 2 by continuing to dump refuse on

the upstream side (Hearing Transcript, Vol. III, p. 25, q. 54). However, in a Notice to Comply with Water Pollution Control Permit, issued by the West Virginia Department of Natural Resources against Buffalo Mining Company, dated March 28, 1968, one of the deficiencies noted is as follows: . 9. Put in proposed refuse dump further up hollow behind impoundment to act as a retaining dam for solids in plant effluent ejected above and this refuse dump will also slow down surface runoff." In a letter of compliance dated May 29, 1968, Mr. Dasovich notified the West Virginia Department of Natural Resources that work had begun on Dam No. 3 and that it would ". . . be completed in the very near future."

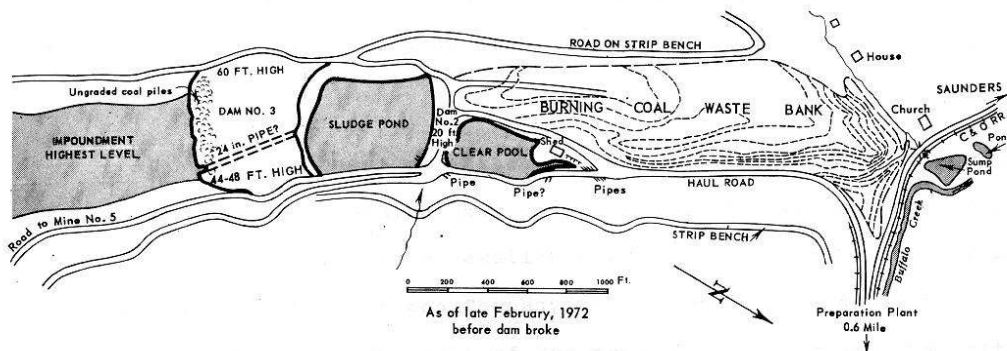
Figure 2-3. Sketch map of Middle Fork, February 1972, before dam broke

Dam No. 3 was constructed by end dumping coal waste from trucks in closely spaced piles from 4 to 7 feet high and then graded in layers 2 to 4 feet thick. The dumping was carried across the valley from the right abutment on the No. 5 mine road toward the left abutment (Figure 2-3). The dumping was done in the form of a single lift (level of material) which ranged up to 60 feet thick. Once the dam had been completed across the valley, dumping was mainly across the back side of the dam which steadily grew upstream. "Trees in the path of the dam construction were not removed but were covered by dumping. The pool area also was not cleared of vegetation. The sludge on which the waste was dumped was only partially displaced and much of it formed the foundation of the dam."<sup>1</sup>

Original estimates by the U. S. Army Corps of Engineers and the U. S. Geological Survey indicated that the sludge deposits were 15 to 20 feet deep. Additional drilling in the area (W. A. Wahler and Associates) indicates that sludge deposits beneath Dam No. 3 range between 40 and 100 feet in thickness. Deposits under Dam No. 2 range between 50 and 100 feet in thickness.

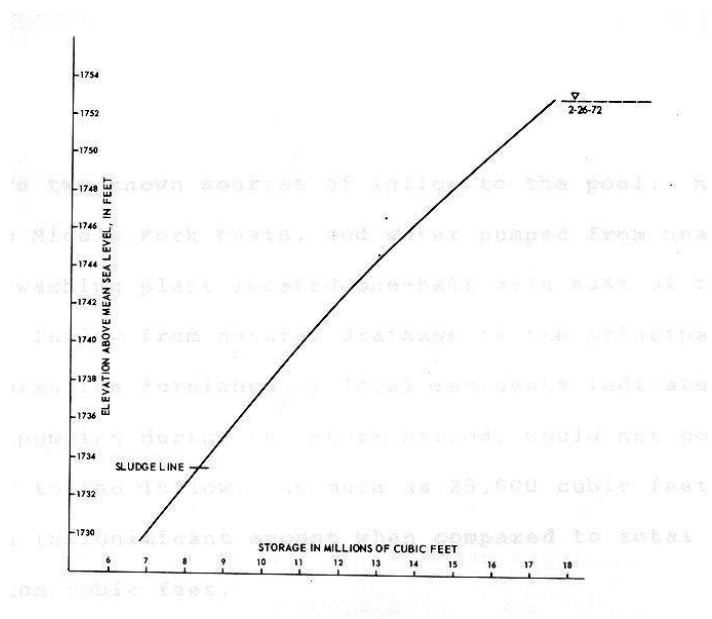
Figure 2-7 Graph showing height of the pool behind coal-waste Dame no 3

Information on inflow and characteristics of the pool behind coal-waste Dam No. 3 were determined from field surveys and interviews with local residents. The pool reached its maximum volume, about 17.6 million cubic feet of water and sludge, around 8:00 a.m. on Saturday, February 26 (Figure 2-7). At that time the water-surface elevation had risen to 1,753.1 feet above mean sea level, and the depth of water in the pool just upstream of the coal-waste dam was 47.3 feet above the level of sludge remaining after failure of the dam. The surface area of the pool at the time of the dam failure was 14.2 acres (Figure 2-8), and the pool extended 2,100 feet up the Middle Fork valley.

The highest sludge line behind Dam No. 3 was at an elevation of 1,733.6 feet m.s.l. (mean sea level). At that elevation, the volume of sludge was 8.4 million cubic feet and the surface area was 10.3 acres.

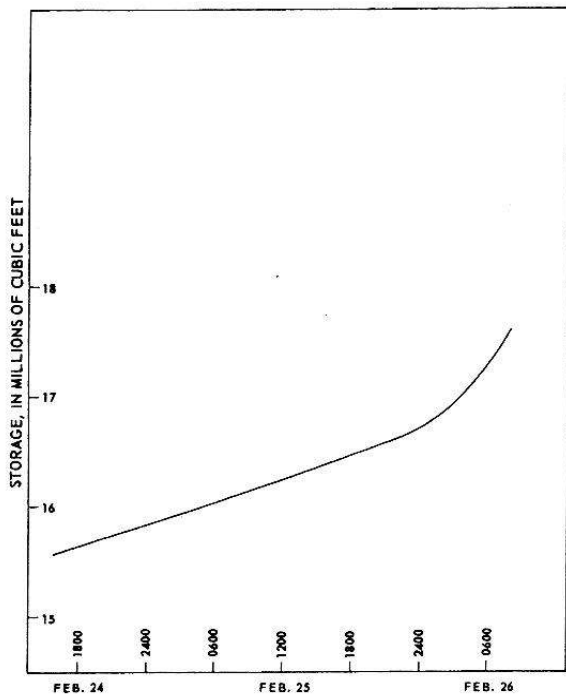
Figure 2-9 Graph showing increase in volume of water in the pool behind coal-waste dam no. 3

There are two known sources of inflow to the pool: natural drainage from middle Fork basin, and water pumped from nearby mines and from the washing plant located one-half mile east of the mouth of Middle Fork. Inflow from natural drainage is the principal source of inflow. Information furnished by local residents indicates that pumping, if there was pumping during the storm period, would not contribute significantly to the inflow. As much as 25,000 cubic feet per day might be pumped, an insignificant amount when compared to total pool volume of 17.6 million cubic feet.

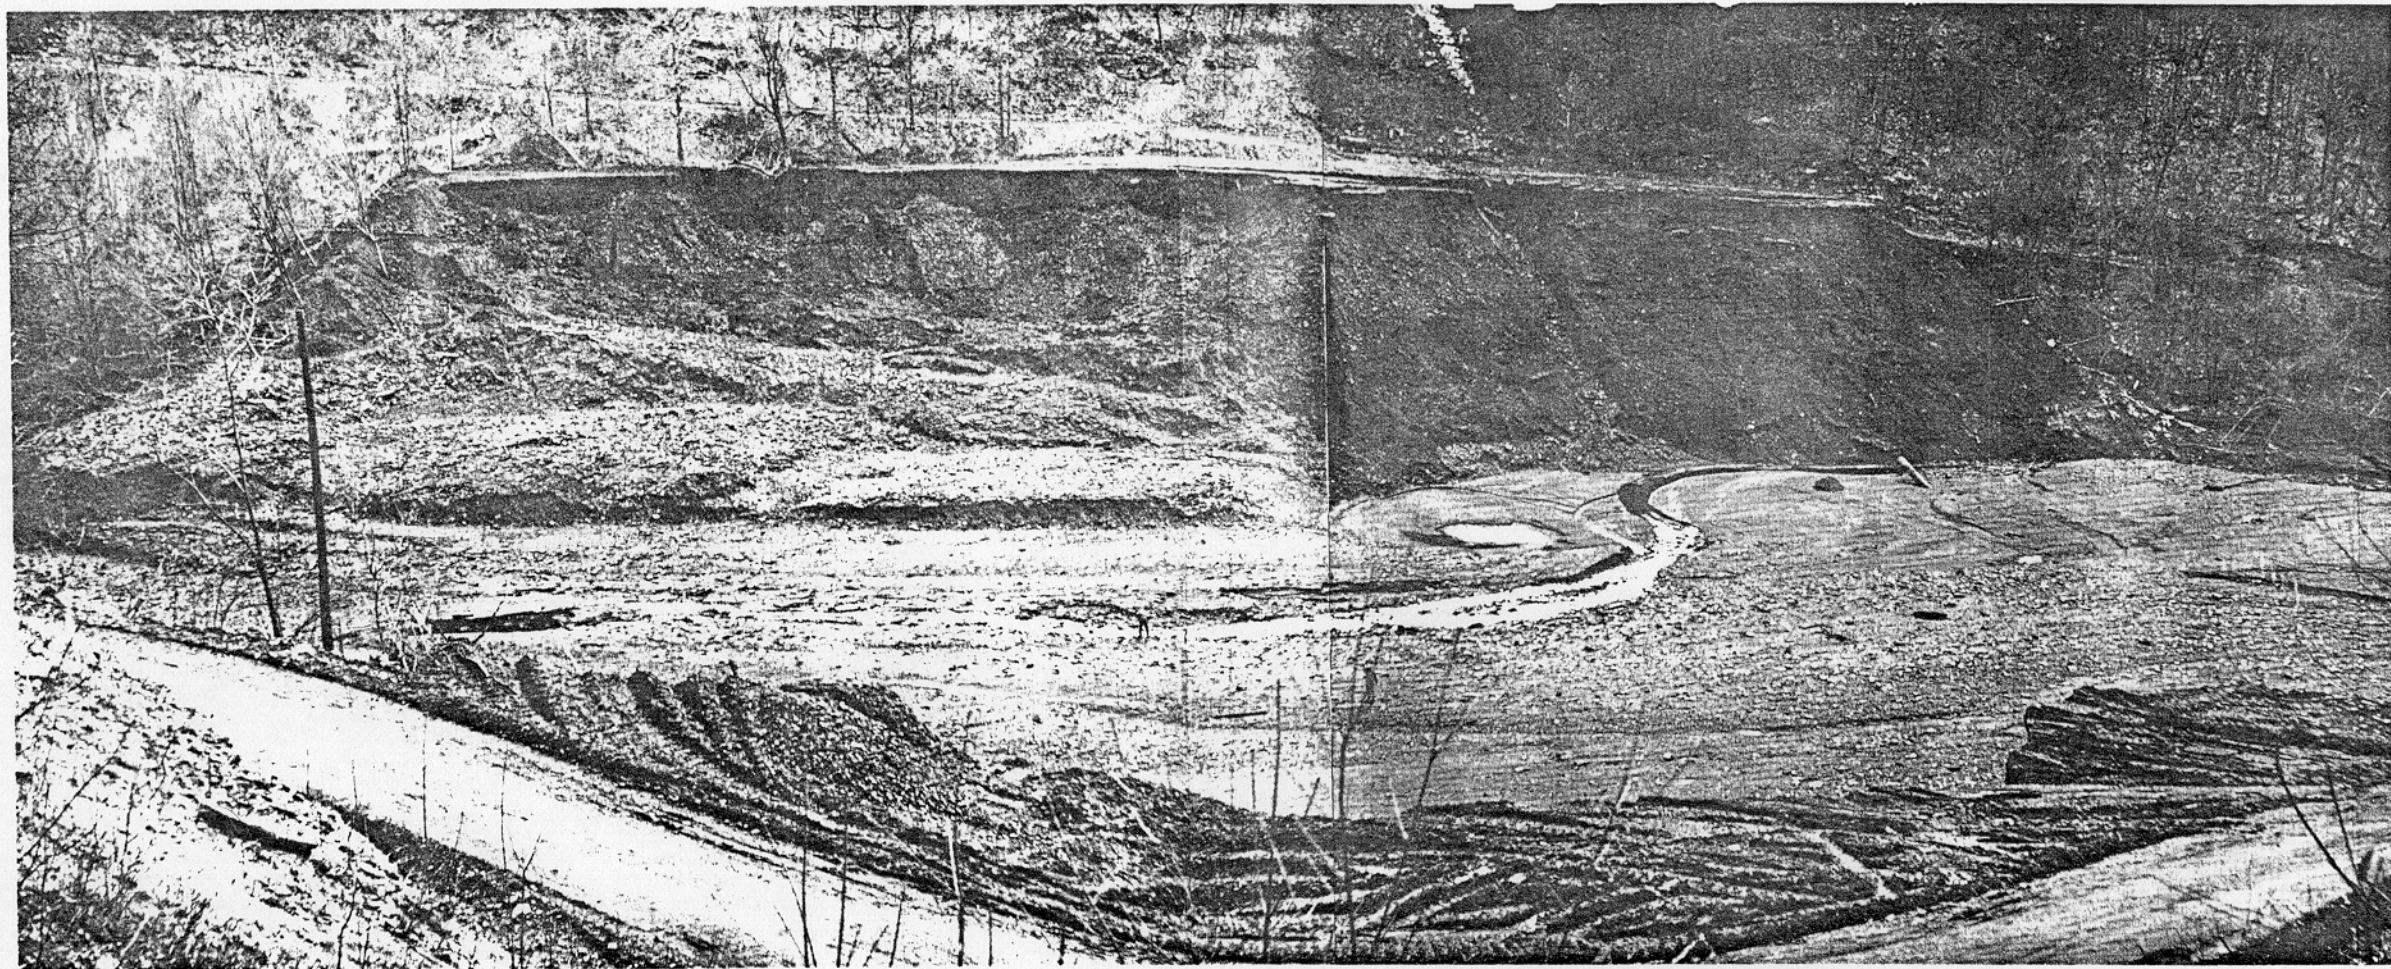
*Figure 2-12. Looking upstream at the left abutment of coal-waste Dam No. 3*

A large dome-shaped mound not eroded or scoured by water action remained at the toe of Dam No. 3 about 120 feet from the left abutment (Figure 2-11 and 2-12). The mound is apparently a remnant of a slump that moved diagonally to the left of the downstream side. Throughout the night of February 25-26, several eyewitnesses reported seeing cracks across the surface of the dam and slumps on the downstream face (Vol. I, p. 189; Vol. II, pp. 35, 89; Vol. III, p. 31).

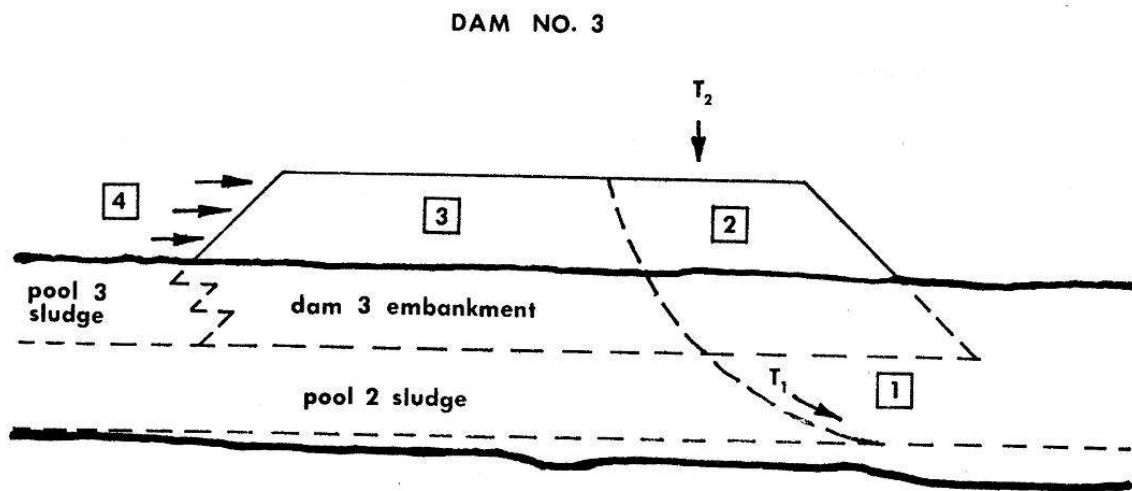
Dam No. 3 was not built using engineering practice standard in earth-dam construction; no foundation preparation was done and no attempt at compaction of the fill material was made other than occasional grading by bulldozer.

- $T_1$  PIPING ACTION THROUGH FOUNDATION
- $T_2$  SUPERSATURATION OF DOWNSTREAM PORTION OF DAM NO. 3 —  
INCREASE IN WEIGHT OF MATERIAL AND THEREFORE THE LOAD  
ON THE FOUNDATION
